# HT 365

## Preservation Coating

### Case History for Indoor Storage at Metals Reclaimer

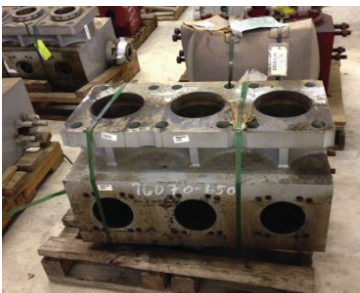
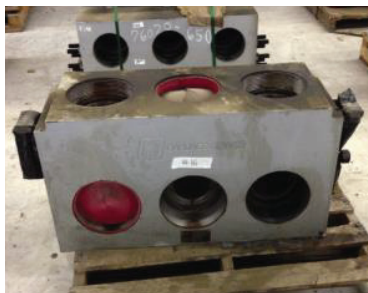
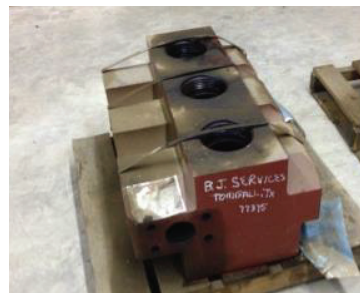
The problem: rust forming on equipment can render it unusable and destroy value. Machine finished, steel “frac” blocks were being stored outside in an unpainted state. With exposure to rain, UV and temperature, unprotected steel begins to develop rust bloom. This rust was occurring both on the body of the block and on threaded areas. Corrosion is especially detrimental to the threaded areas in the block, potentially rendering the block unusable because of the minimal tolerance of the threads to physical surface change that rust can cause.

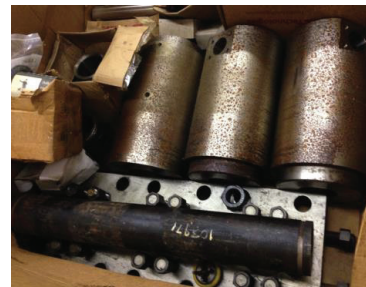
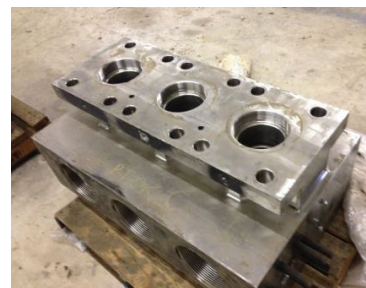
Customer shared 6 months later that HT 365 continued to protect the steel. After nine months, all surfaces coated with HT 365 were rust-free, especially in the threaded areas. This result preserves the functionality of the block and value for eventual resale.

HT 365 was applied with a pump-style garden sprayer at a .4-.5 mil dft on the body of the block with particular attention to threaded areas. The blocks were stored in a warehouse where the temperature and humidity is not controlled.
