# HT 365

## Preservation Coating

### Case History for Indoor Storage at Valve Manufacturer

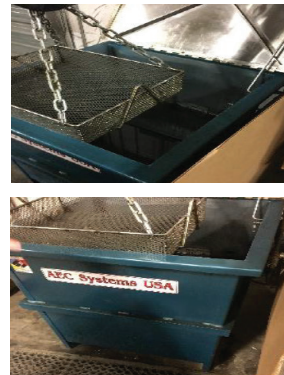
In the summer of 2015, the valve manufacturer decided that as new bare steel parts were received, they should be protected from corrosion and chose to test HT 365 as a thin film coating to provide protection of the steel for up to one year. It was decided to dip each piece while lying in a stainless steel basket in a vat filled with HT 365. The dipping station was specifically built for HT 365 and holds 40 gallons of coating.

The parts are dipped and allowed to fully coat all exposed surfaces, then raised and allowed to drip dry. After five minutes, the film is cured and the part is ready to go into storage on the shelf. The customer began dipping parts in November, 2015 and fifteen (15) months later, they are still receiving full protection and are rust free.

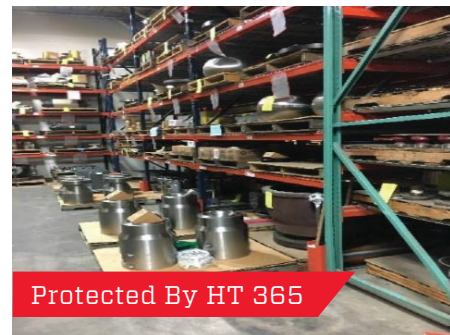
The valve manufacturer has found that the time spent to protect the steel by dipping each piece into the vat to coat with HT 365 was a time and cost saver as the need to remove rust when needing to assemble a valve can be inefficient and add another expense to the cost of goods sold. The below pieces have thus far been rust free for over 15 months and expected to remain that way for a while. Should additional protection be needed, the manufacturer can simply dip the parts again for another long period of protection. Below is an example of the 15 months of protection provided by HT 365. Coated November, 2015; still protected as of February, 2017.

Next to the rust free parts on the pallet are valve bodies that were not protected and are completely rusted. Unfortunately, they will have to be blasted before assembly.
